EXPERIENCE FEEDBACK ON THE USE OF THE GEOSYNTHETICS IN ALGERIA IN THE FIELD OF PUBLIC WORKS

Rabah Arab¹, Saïd Tabti² & Messaoud Zermani³

TREATMENT OF A LANDSLIP AND CONSTRUCTION OF A ROAD SURFACE

ACCESS RAMP TO A FLYOVER IN CONSTANTINE

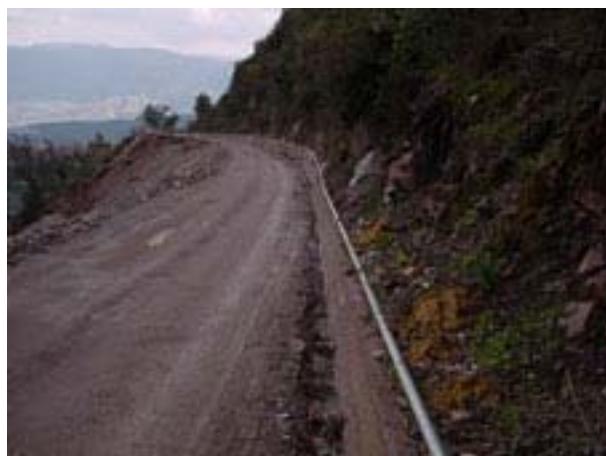
Landslips are natural occurrences and are often caused by the presence and/or passage of water in the ground. The landslip examined occurred in a mountainous region following heavy rain. The slip affected the downhill side of the road over a distance of approximately 80 m (Figure1)

Figure 1. View of the landslip

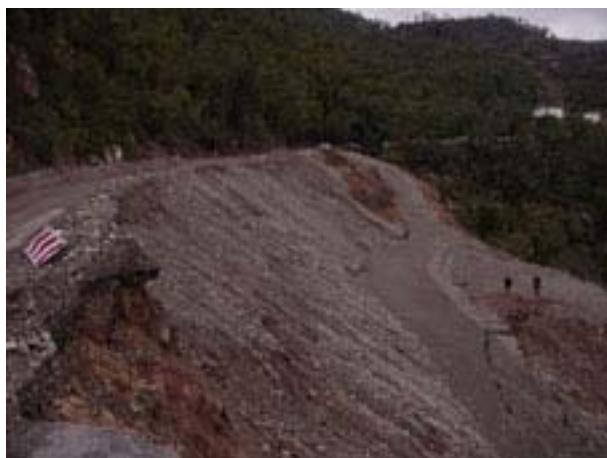
Figure 3. Longitudinal cracks which appeared due to the load of new soil

Several technical solutions were proposed to the authorities to deal with the landslip problem and reconstruct the road. One of these solutions was to clear away the entire slip zone and reconstruct the embankment with a slope of 3H/2V using a clean coarse fill material (TVO), compacted in successive layers of 0.3 m. The drainage of water infiltrating from the top being provided with a granular drainage course. This solution was adopted, but during execution, longitudinal cracks appeared at the top and bottom of the new embankment created before the final thickness was attained (Figure 3). Upon detection of this problem, the owner and main contractor agreed to stop work and examine alternative solutions.

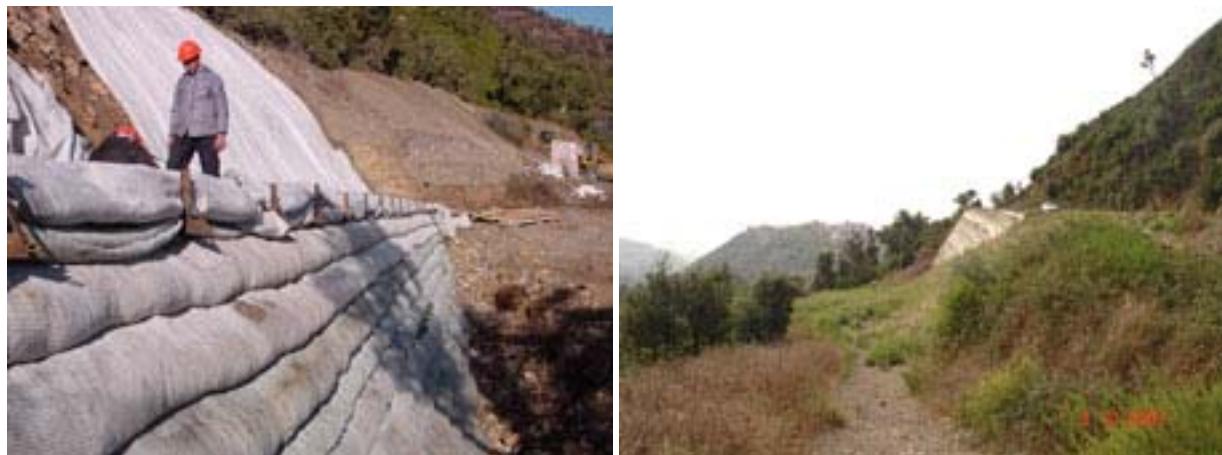
The work was carried out in several stages. After clearing all landslip top soil and earth removal work to attain the substratum, a drainage trench was created. The drainage geocomposite was rolled out directly onto the exposed embankment and overlapped into the drainage trench. The fill material is composed of 0.4 m thick layers and compacted to obtain optimum proctor value. The "beading" surface form is created using simple removable shuttering (Figure 5). The future vegetation of this surface is achieved by applying a layer of top soil held in place with a geo-net type Geotalus.

Figure 5. Views of the site during and after construction

Appropriate site organisation enabled total compliance with the deadlines imposed by the owner while ensuring the road remained open for traffic during the construction phase. Figure 5 b shows the site when finished. Once completed, this new embankment not only enabled reconstruction of the road surface but also its widening over a distance of approximately 50 m.

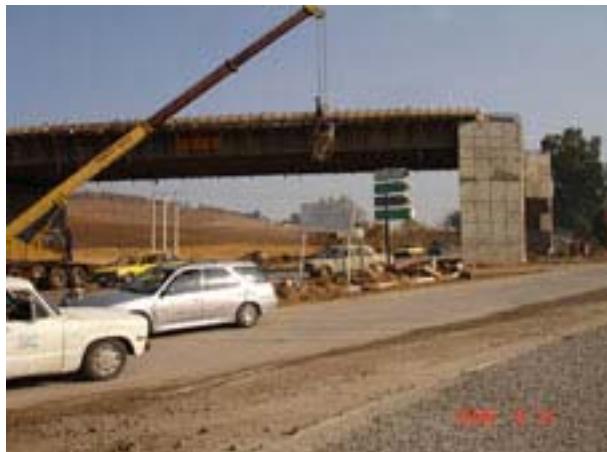
Figure 6. View of the flyover

To improve traffic conditions between the towns of Constantine and Didouche Mourad in Eastern Algeria, it was decided to construct a flyover (Figure 6). The owner (Public Roadwork Department) was in search of an efficient

technical solution to reinforce the embankments of the access roads and blend in harmoniously with the surrounding environment.

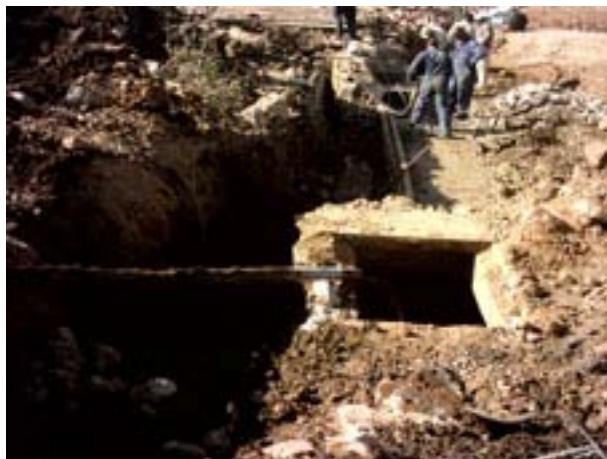
Various solutions were examined, in particular the solution of creating a reinforced concrete wall. This solution was discarded at it required the creation of deep foundations passing through the existing utility systems (drains, electricity, gas, etc.) which would have to be re-run with a subsequent increase in project duration and cost (Figure 7).

Figure 7. View of the various utility networks

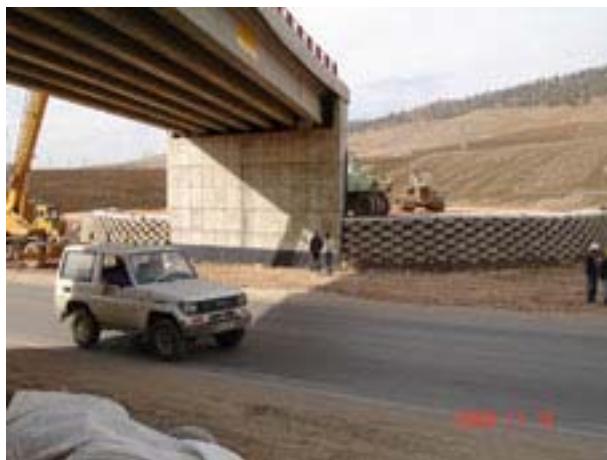
Figure 10. View of the work in progress

- Emplacement of ramps and base for elements atalus120.
- Surface clearance of the entire project zone
- Creation of a concrete foundation with a density of 250kg
- Installation of the cellular elements and a geotextile layer
- Application of a 0.25 m compacted layer of landfill material, followed by a compaction test,
- Introduction of top soil,
- Installation of a watering system.

Figures 10, 11 and 12 respectively illustrate construction during and after work completion.

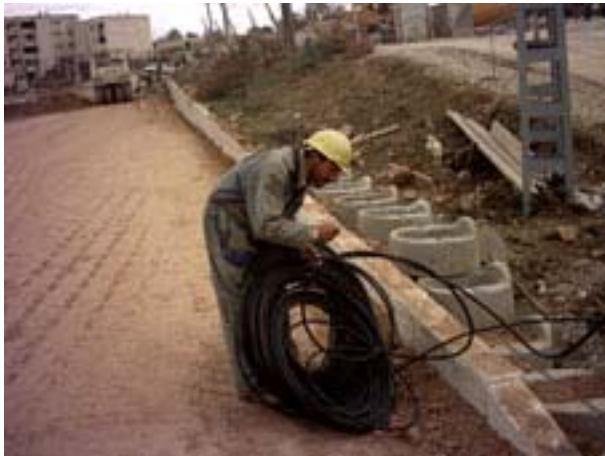
Figure 11. Installation of the watering system

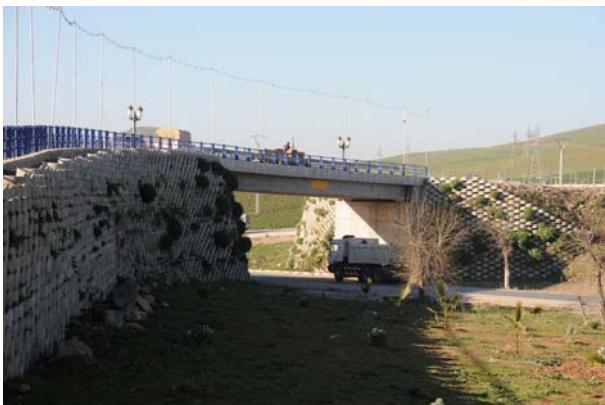
Figure 12. The completed construction

The technical specifications and deadlines imposed by the owner and main contractor were complied with thanks to the used of geotextiles in combination with modular cellular blocks while using locally extracted materials and local labour.
