# Experiment of the use of geosynthetics for the drainage in place of draining masks – Hydraulic properties and sustainability

**ABSTRACT:** An experimental site was chosen to compare hydraulic properties of a geosynthetic and granular materials used for the drainage in earthworks to ensure slopes stability with draining masks. This paper presents the way the instrumentation was installed, and how this experimental site was monitored in order to follow the behavior of the geocomposite, the evolution of the flow during seasons, with respect to the traditional way, and to appreciate potential clogging. First results are available and consistent: they show both techniques protect grounds below from rain infiltration and frost, that water occurrences are drained, with a distinction between the two techniques. Those conclusions are so far only based on five months data, so the experiment must be followed further months to appreciate behaviors regarding to different seasons, and several years in order to appreciate clogging and stability problems.

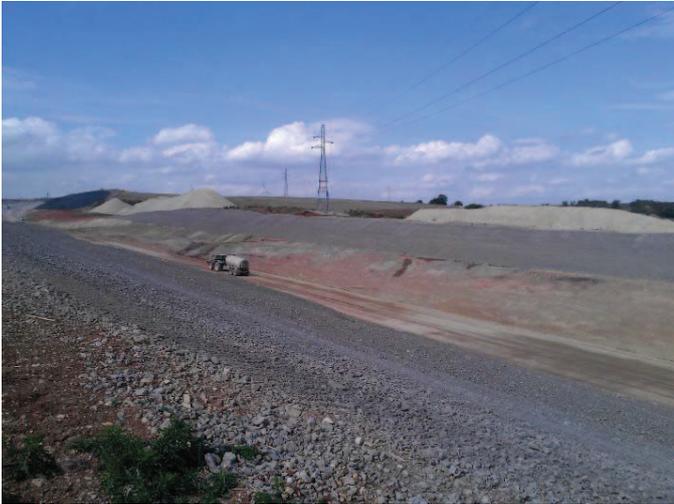
The main difficulty of the choice was to find a bank remotely located from rail tracks, in its high part (requirements for safety measures), and with water occurrences to allow the comparison. This choice is illustrated on Figures 1 and 2.

Figure 1: site global view

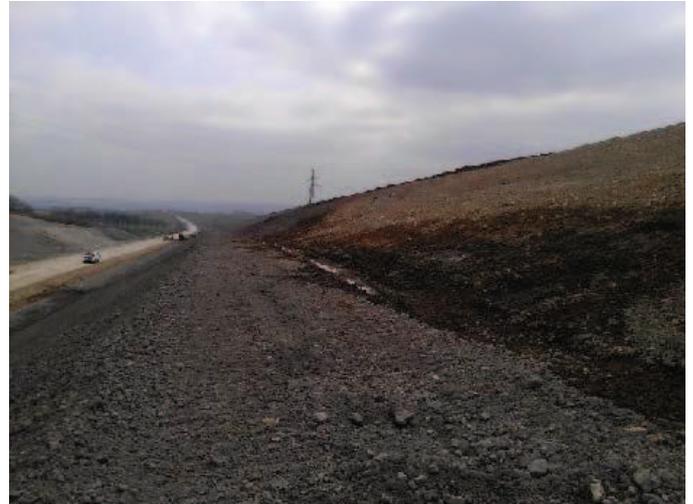
Figure 2: water occurrences (dark areas)

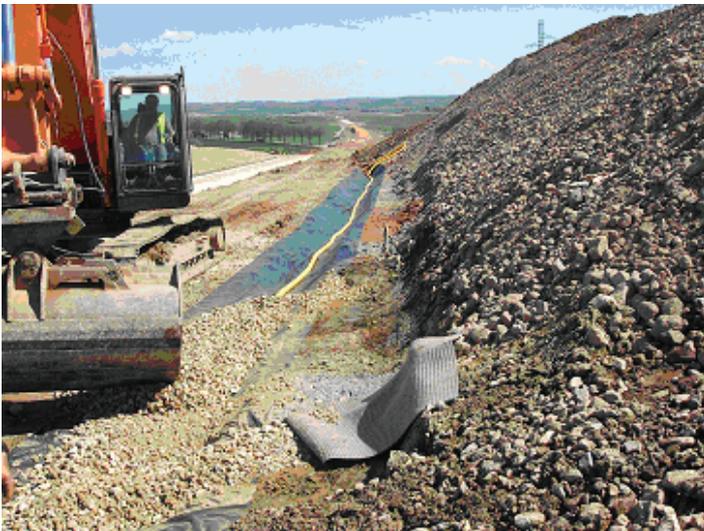
Experimental parts have a surface of 525 m<sup>2</sup> each (15mx35m) and were elaborated in April 2013, with Eiffage, in charge of earthworks. The traditional part consisted in aggregates provided by the infrastructure owner, with a thickness of 50 cm. As shown on figures 3 and 4, ditches were created down below each testing area, in order to collect water occurrences.

Figure 3: traditional experimental part

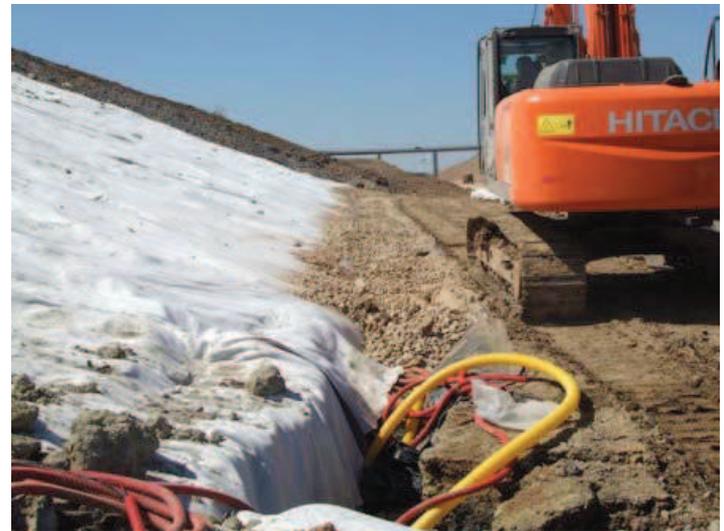
Figure 4: geocomposite experimental part

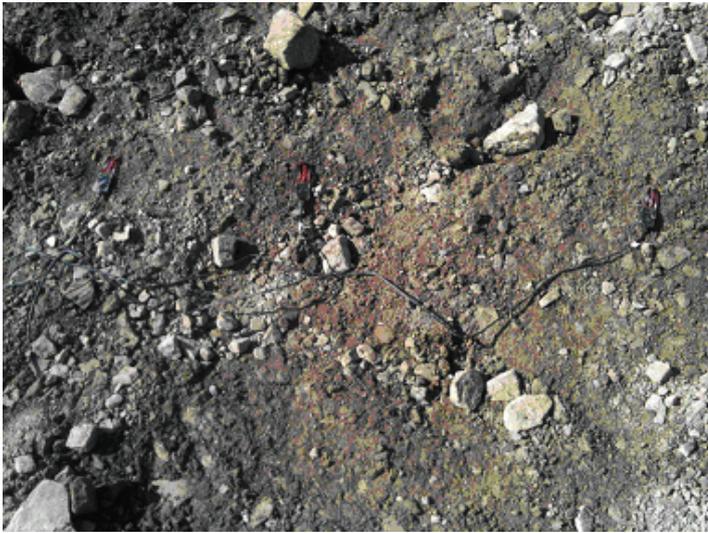
within one small draining device, A, while another monitors temperature in the chamber, B ; this chamber shelters instruments from adverse weather conditions. All dataloggers where the instruments are connected to were left on the site with an energy supplier for their autonomy. Illustrations of this instrumentation are provided on Figures 7 and 8.

Figure 7: temperature and water content sensors

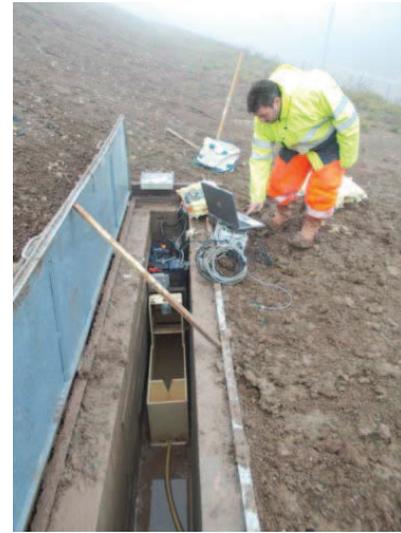
Figure 8: chamber with flow rate measurement
