Improved QA and QC of Double-Lined Ponds for Processed Water Containment

Heather D. McDaniel, Souder Miller & Associates, USA

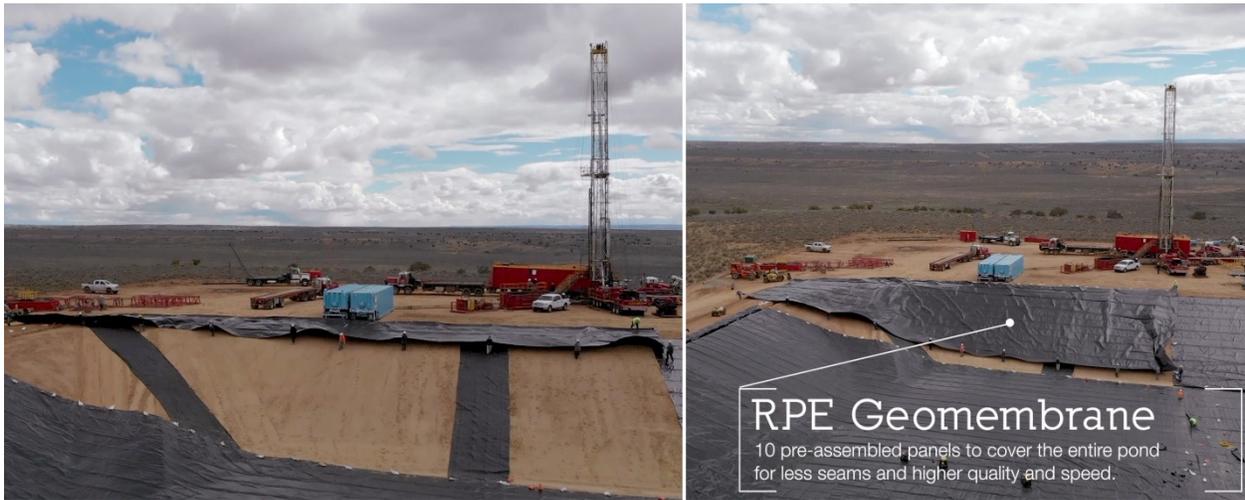
Figure 5: Deployment of a RPE panel in the slope

Figure 5 shows how to deploy each panel of RPE. Because larger panels can be pre-assembled at the factory, the installation allows for fewer seams in the field, reducing the risk of leaks at the joints compared to a traditional installation with narrow rolls. For this reason, the installation of the liner is faster and safer.

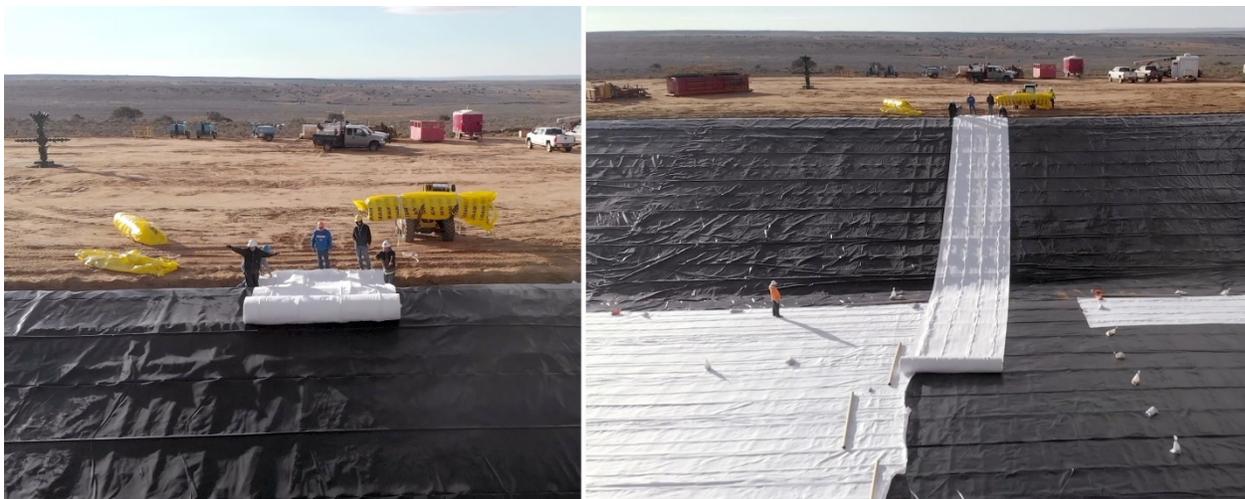
Figure 6: Deployment of the conductive multi-linear DRAINTUBE from the top of the slope

Figure 6 shows the lightness of the multi-linear drainage geocomposite. The rolls can be handled like geotextiles, unrolled from the top of the slope. Also, their structure is soft enough against the liner to avoid any risk of perforation due to heavy loads or harsh angles of plastic. Also, the installation is accelerated (in the order of 20 to 30% more productivity) and a lot safer for the crew than the installation of a geonet-type drainage geocomposite. Indeed, as most multi-linear drainage geocomposites products are made of

geotextiles and plastic pipes, they can be easily cut with traditional tools, whereas cutting a rigid heavy geonet might take longer and have increased risks of cuts to workers' hands.

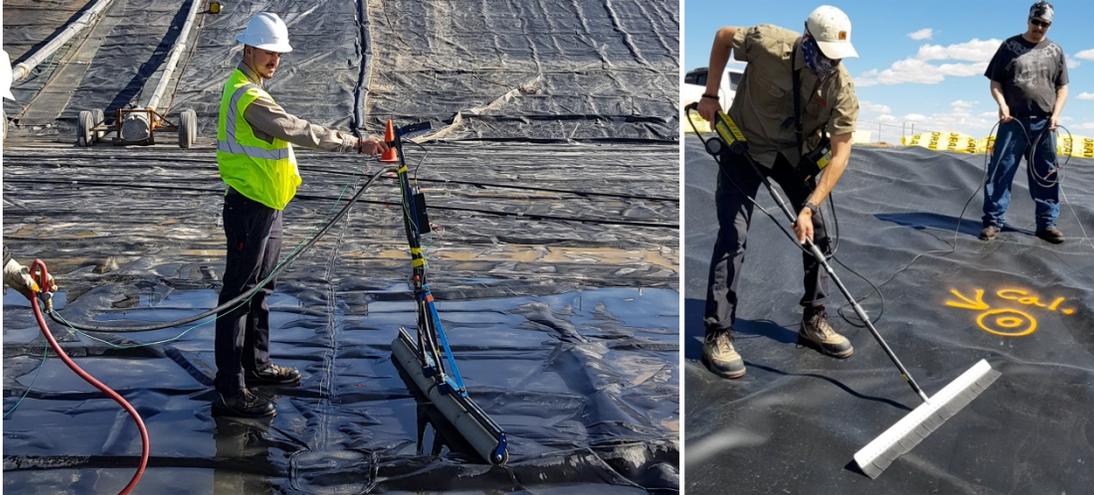
Figure 7a: Water puddle method; Figure 7b: Arc test method

Leak location surveys have been conducted on each of the subsequent ponds based on lessons learned from the initial installation. Due to the liner surface type and slope the leak location surveys have been conducted depending on whether the survey was targeting the slopes or the bottom. The water puddle method (see Figure 7a) was selected by the client to control the integrity of the ponds in the bottom. The arc test method (see Figure 7b) was used in the slopes of each pond.

For each test, the conductive multi-linear drainage geocomposite offered an adequate sensitivity (arc test and water puddle) and permitted the detection of holes ranging in size from large (Figure 8) to very small holes (1 mm in diameter which was the size of the calibration hole; see Figure 7b).

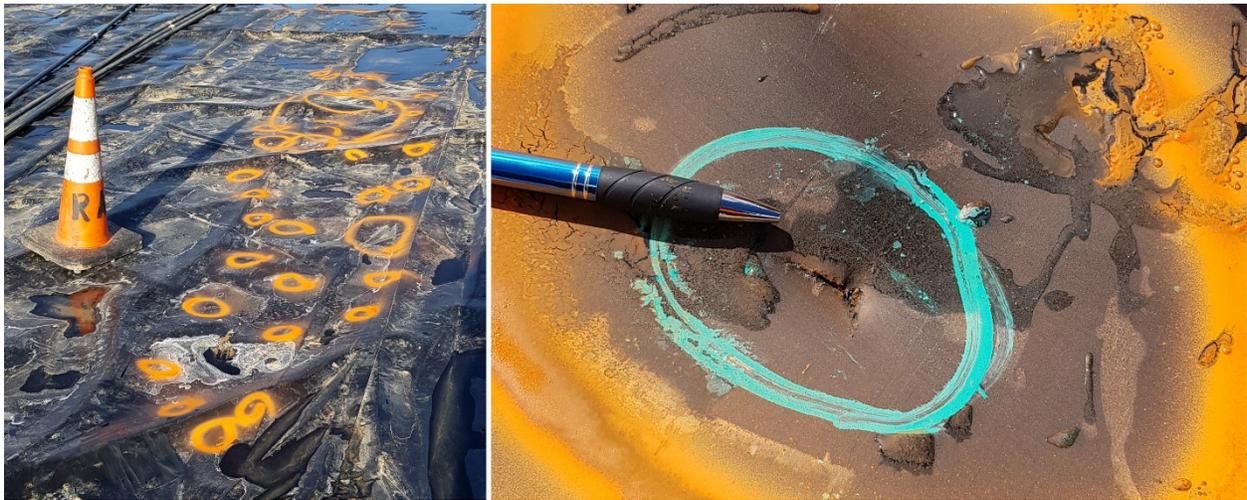
Figure 8: Example of leaks found on the primary liner at the bottom

The results of the primary liner electronic leak location survey yielded 70 holes in the bottom of one of the pits and 8 in the second one. Additional issues were identified that were contributing to the leakage rate, such as the LLDPE material being damaged by the high-pressure cleaning, seams had been impacted during removal of drill cutting removal, and holes had been generated by inappropriate access to the liner (see Figure 8).

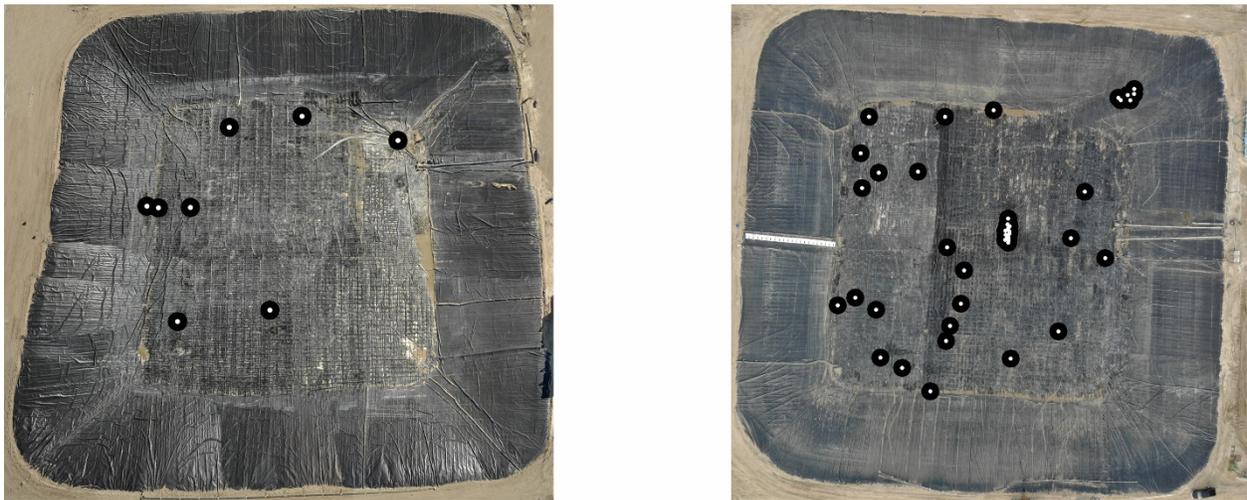
Figure 9a: Pond A (8 leaks); Figure 9b: Pond B (70 leaks)
